GEND-INF-067

EXAMINATION OF THE LEADSCREW SUPPORT TUBE  
FROM THREE MILE ISLAND REACTOR UNIT 2

Published March 1986

Battelle Columbus Laboratories  
505 King Avenue  
Columbus, Ohio 43201

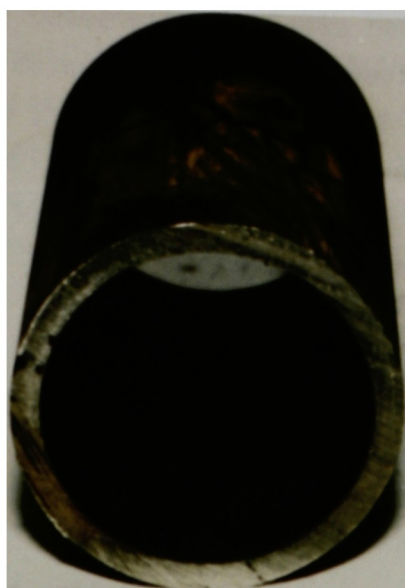
Figure 3. Color photograph showing the inside surface of the LST section.

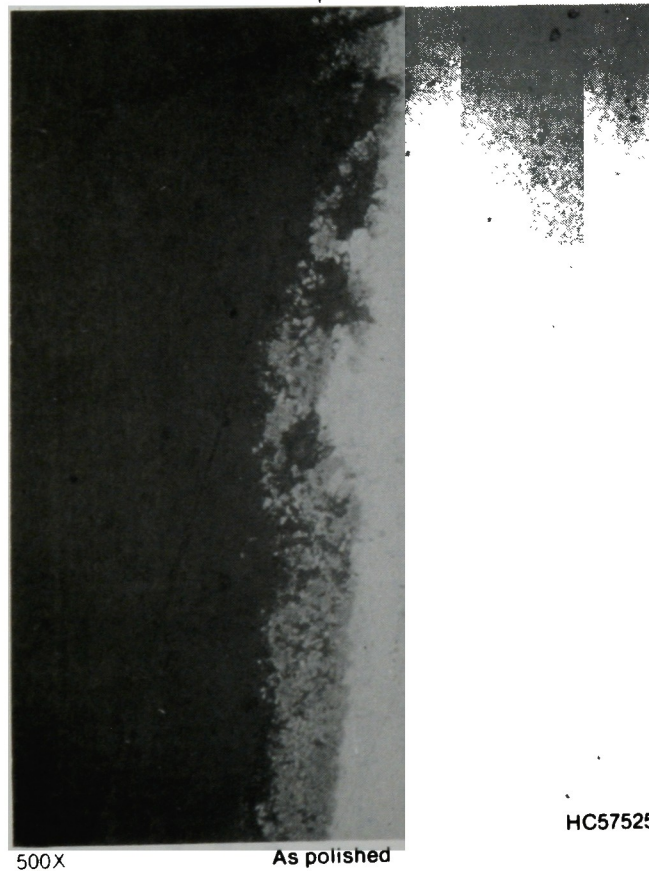
Figure 14. High-magnification photomicrographs showing the typical appearance of inner and outer surface deposits on Specimen 1-1 (note absence of metallic particles in inner surface deposit).

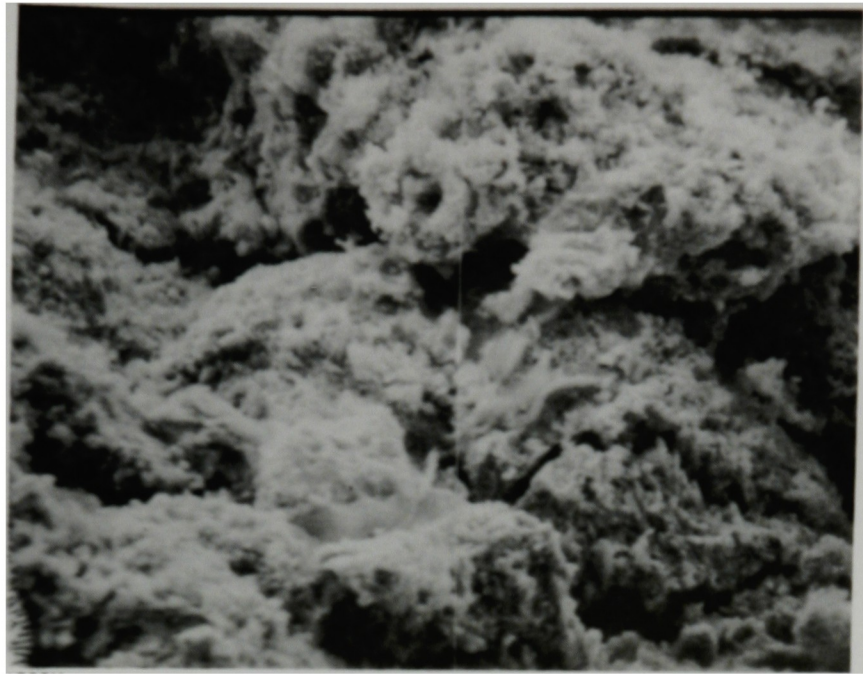
Figure 24. X-ray map for silver, showing localized enhancement in silver concentration in the loosely adherent deposit of Specimen 5-1.
